Causes of Failure and Repair Strategies for Flexible Pavements in Afghanistan

Rahim Gul Zadran¹ and Braila Natalia Vasilievna²

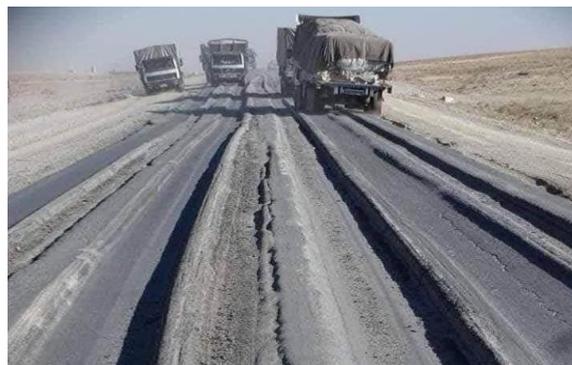
Figure 1. Rutting along the Kabul-Kandahar road.

Rutting is an important challenge for the preservation and performance of flexible pavements in Afghanistan [15]. It is described by development of permanent depressions in the wheel paths of the roads, which occur due to the movement of heavy vehicles over a road portion. For example, you can see the Kabul-Kandahar highway in the Fig 1, where heavy trucks transporting goods between major cities have caused severe rutting. The onset of ruts not only reduces the roadway conditions but also can cause serious threats to the safety of the motorists. Exploring the factors of rutting is critical for dealing with this problem in the aging road systems of Afghanistan.

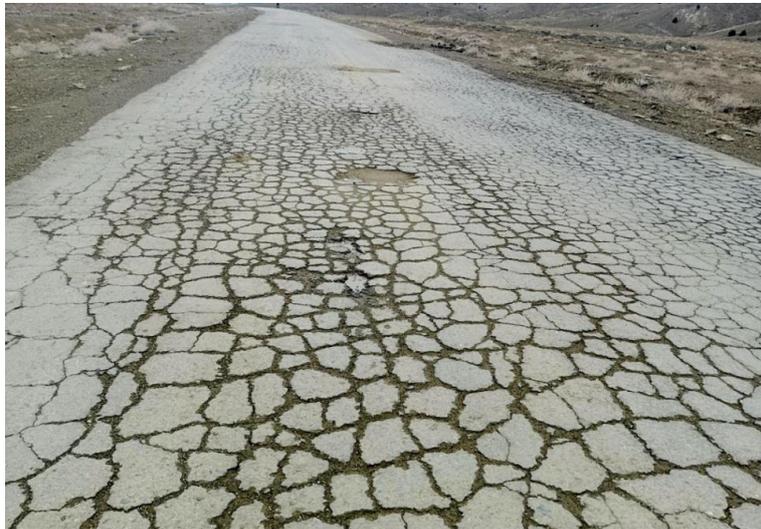
Figure. 2. A Road in Paktia has cracks and potholes due to its poor drainage system.

Alligator Cracking: Alligator cracking is frequently associated with chronic fatigue and overloading bottom-up breaking from alligator cracks that gets worse with the rest beats from big trucks. Poor drainage and no major power may aggravate the cracks even further [36]. Alligator cracking is common on roads leading to agricultural and mountain areas. Heavy trucks transporting crops overload the pavement, while poor drainage systems allow water to seep into the subgrade, weakening the base layer [37].

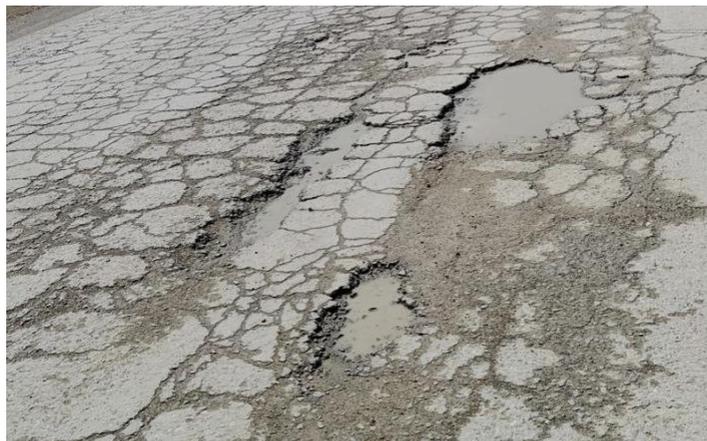
Fig. 2. A Road in Jalalabad with potholes.

Road infrastructure is very much affected by potholes -a bowl shaped depression that cuts through the Hot Mix Asphalt (HMA) and goes deep down to the base course [46]. These potholes are chunky and consists of a sharp edge which makes it dangerous for vehicles to move at high speeds [47]. Such conditions are often found on roads which has HMA surface of 25mm to 50 mm and hardly comes across in roads that have 100 mm deep surfaces [48]. Afghanistan is known for using low grade materials for construction of roads making it unable to support stress from heavy traffic load which leads to fatigue cracking [35]. The well-known Kabul-Jalalabad and Kandahar-Herat highways are notorious for their poor condition. You can see in the Fig. 3 a road in Jalalabad that has many potholes and makes it very difficult for vehicles to drive properly. When there is moisture seepage, which especially happens during the rainy season, it erodes the overall health of the pavement. This is because the trapped water gets a chance to freeze which later expands and cracks the pavements even more. Moreover, there is a lack of required maintenance from both local or international institutions for constant better upkeep which worse the problem [18].

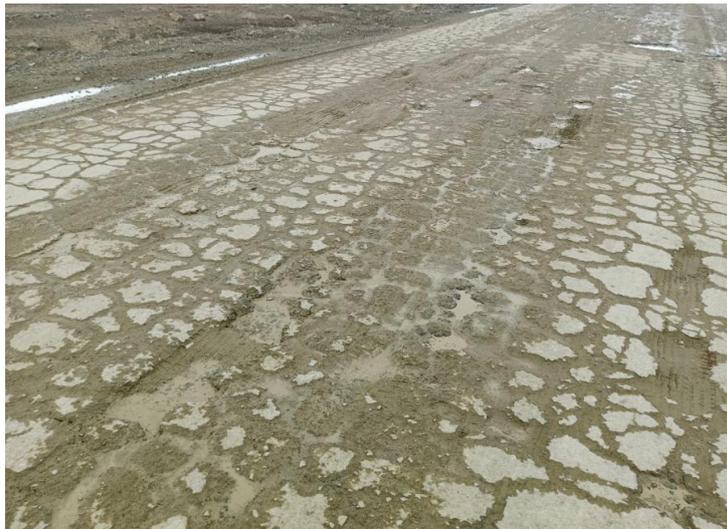
Fig. 3. Pavement deterioration in Nuristan from rainfall-induced potholes and erosion.

Precipitation: The precipitation in any form can affect flexible pavements. Especially in spring, these regions, especially Badakhshan and Nuristan, get substantial surface water on their roads which can impair the skid resistance and increase the chance of hydroplaning, and as such, become prone to get damaged easily requiring surface maintenance frequently [49].

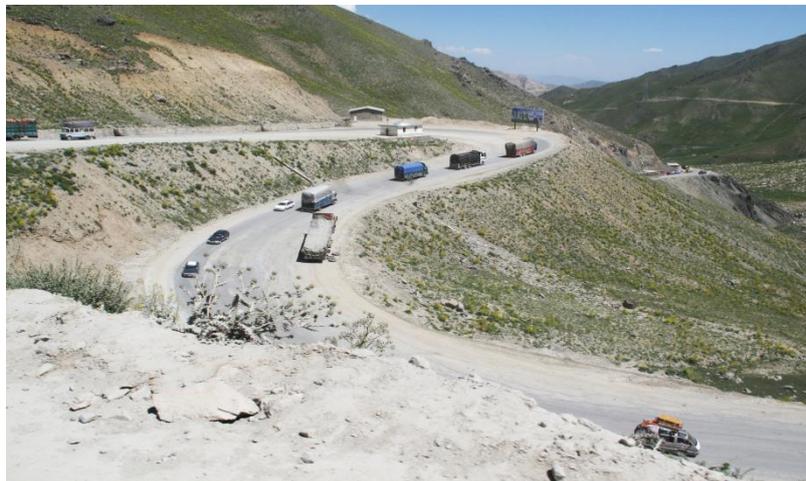
Figure 3. Pavement stress from poor alignment (Salang Pass)

Weak horizontal and vertical alignments: Steep gradients and sharp curves are prevalent within mountainous regions [15, 65]. One of the most important routes, Salang Pass [66], is burdened with inadequate design caliber leading to severe portion of the pavement over curvature stress. Such conditions result in the frequent damages to the road that lead to constant spending of large sums of money for reparations.
